USAAEFA Project No. 76-09-1

ARTIFICIAL ICING TEST
UTILITY TACTICAL TRANSPORT
AIRCRAFT SYSTEM (UTTAS)
SIKORSKY YUH-60A HELICOPTER

FINAL REPORT

FEBRUARY 1977

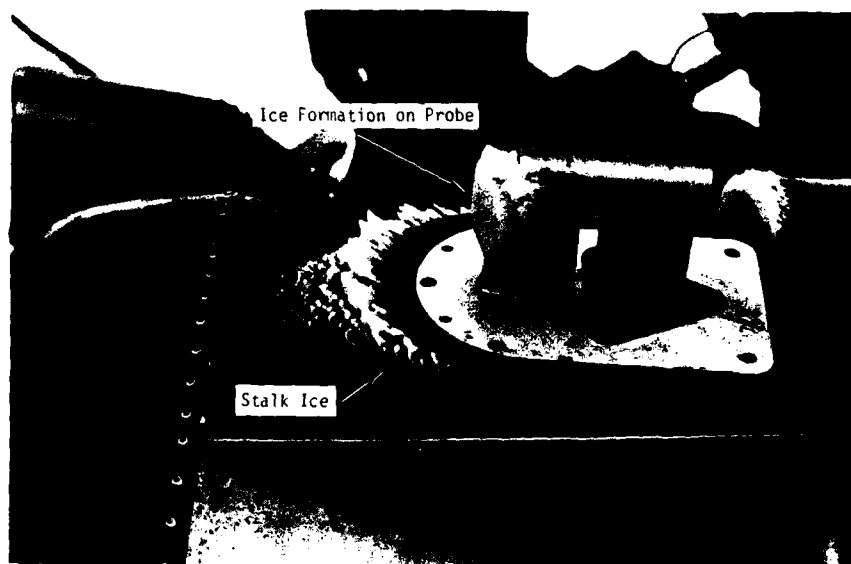
15. After flight 16, visual inspection of the aspirated Rosemount ice detector probe mounted on the No. 1 engine nacelle (photo 1, app H) revealed that the probe had frozen over. A continuity check was made of the heater element circuit, and a broken wire was discovered. The broken wire was repaired and no additional probe freeze-up occurred.

Photo 1. Aspirated Rosemount 851F Icing Rate Detector After Flight 16.

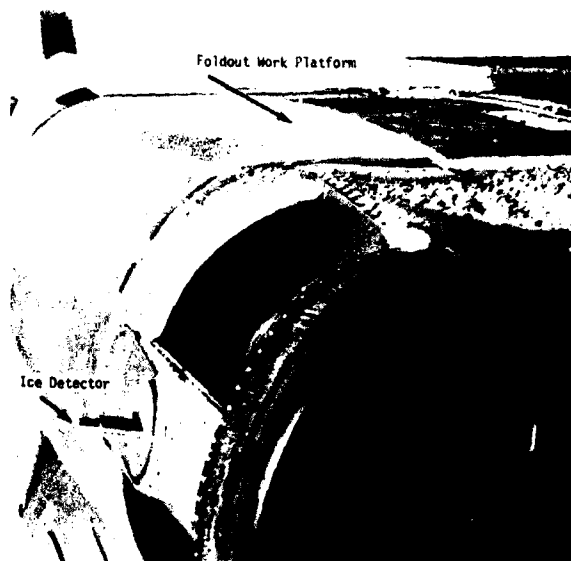
41. Ice accretion patterns around the engine nacelle, similar to that shown in photo 2, appendix H, were observed after each icing flight. The amount accreted varied as a function of time and there was no evidence of natural shedding. Ice also accreted on the wiring and fire extinguisher discharge tube just inside the engine cooling air inlet. The presence of ice and moisture within the engine nacelle is a potential electrical problem, and proper protection should be provided for all moisture-intolerant components in the engine nacelle.

Photo 2. Rosemount 851F Icing Rate Detector Location.
